Attachment F

Railroad Rehabilitation Assessment
Willits MP 139.5 to Longvale MP 152.5

This Assessment was completed to determine an estimated cost necessary to rehabilitate 13 miles of GRTA Rail Line from Willits, CA MP 139.5 north to Longvale, CA MP 152.5 to FRA Class 1 track standards for freight rail service.

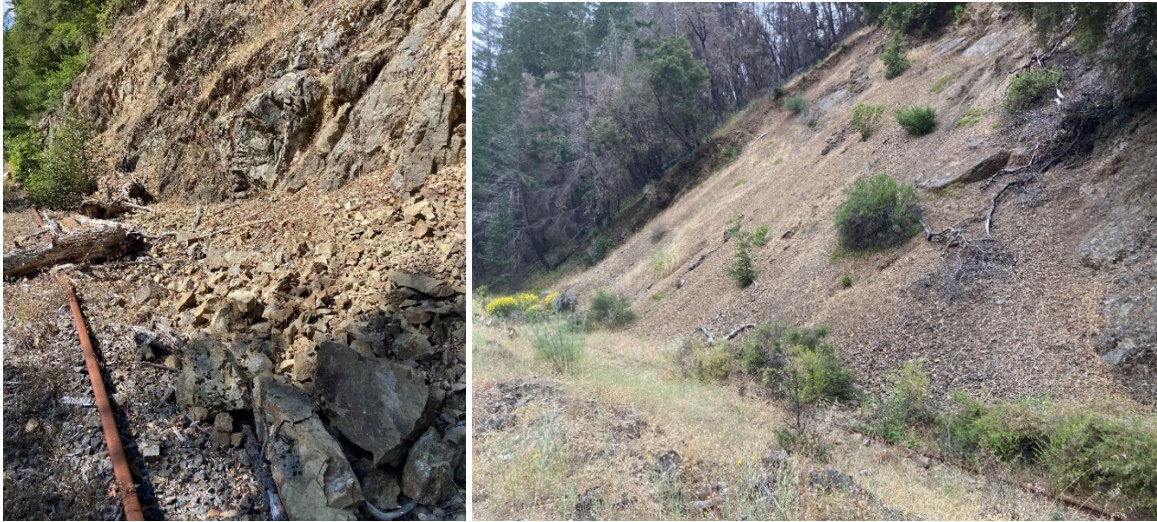
Photo 1 Typical slide example

Photo 2 MP 146.0 Talus slope

Ditching at Slides: There are several areas that require ditching due to rock and debris slides. The rockslides consist of fracture rock, mixed soil, and woody debris resulting in talus slopes. It is evident at several of these slide areas that they have required substantial clearing over time based on large stockpiles of material on the opposite side of the track from ditching. In areas of recurring larger rock falls it is recommended that rock slopes be scaled and catchment walls constructed with K-Rail Barriers.

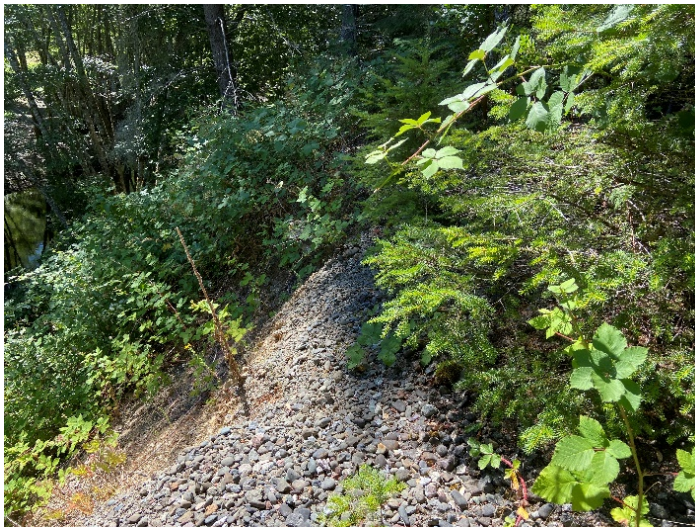
Photo 3 MP 151.6 steep slope at Outlet Creek.

Shoulder Walls: As a result of steep embankment slopes and bank erosion along bends of Outlet Creek, four locations require shoulder retaining walls. Shannon & Wilson geotechnical engineers recommend cast-in-place concrete or shotcrete walls supported on vertical micropiles installed from the roadbed as the most economical solution. The four locations are: MPs 148.9, MP 151.0, MP 151.6, and MP 151.8. At MP 151.6 a field visit measured the distance from face-of-rail to top-of-embankment down slope of 4.0 feet. See Photo 3 and Photo 4 showing the steep railroad embankment on the right side of the track and at the same location the left side of the track with poor drainage. At MP's 148.9 and 152.6 Photos 5 and 6 show bare earth LiDAR views of the erosion of Outlet Creek which is very susceptible to frequent high flows in the rainy season.

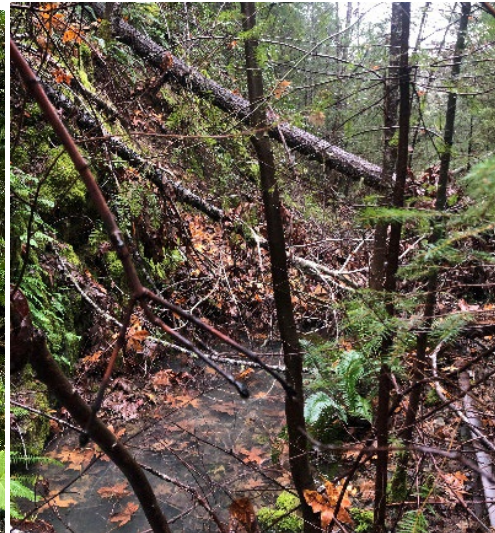
Photo 4 MP 151.6 poor drainage

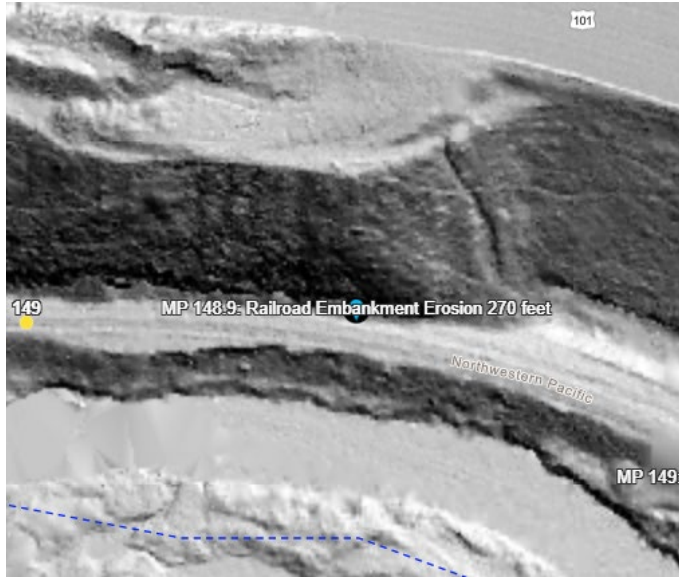
Photo 5 LiDAR image MP 148.9 erosion at Outlet Creek

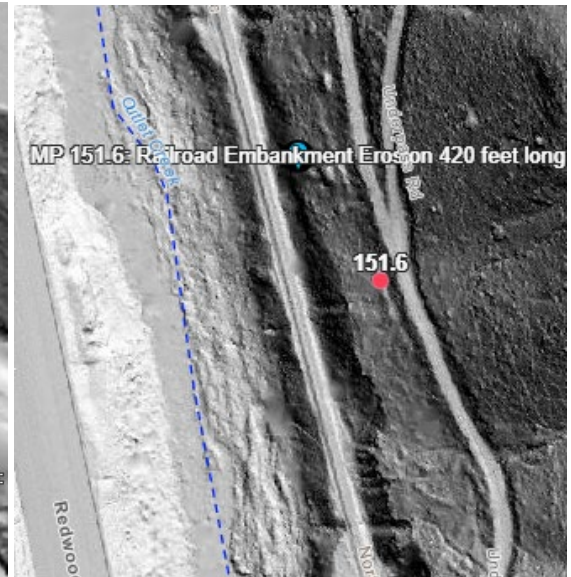
Photo 6 LiDAR image MP 151.6 erosion

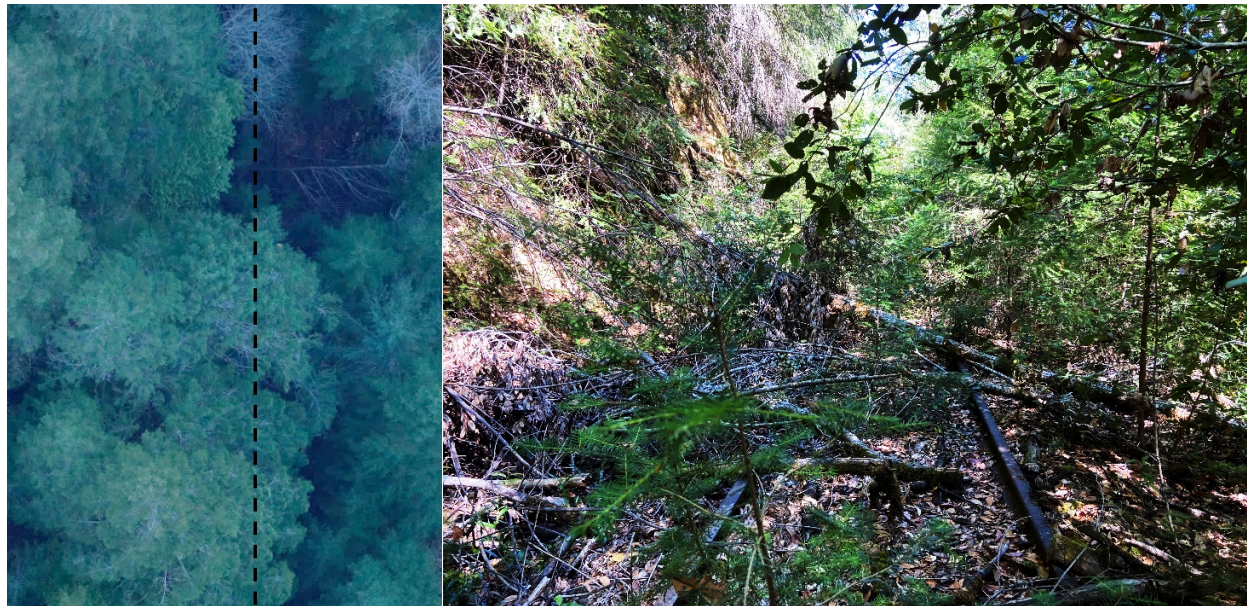
Photo 7 Example of Heavy Vegetation Canopy over Rail Right-of-way MP 150.6 (dashed line is centerline of track) *Photo 8 Example of Heavy Vegetation at Track Level MP 150.6*

Vegetation needs to be cleared 15 feet to 20 feet horizontally from centerline of track and 20 feet vertically to provide required site distance, safety of train crew, and to minimize fire hazard. The cost to clear vegetation assumes using an on-track mounted brush cutter to clear 6 miles and spreading the chipped debris on the right of way. The 6 miles of brush cutting would cover all but the 7 miles of heavy vegetation. Heavy vegetation includes 20-to-30-foot-tall trees mixed with low level shrubs, small trees and fallen trees from up slopes. See Photo 7 showing an aerial view of tree canopies and Photo 8 taken

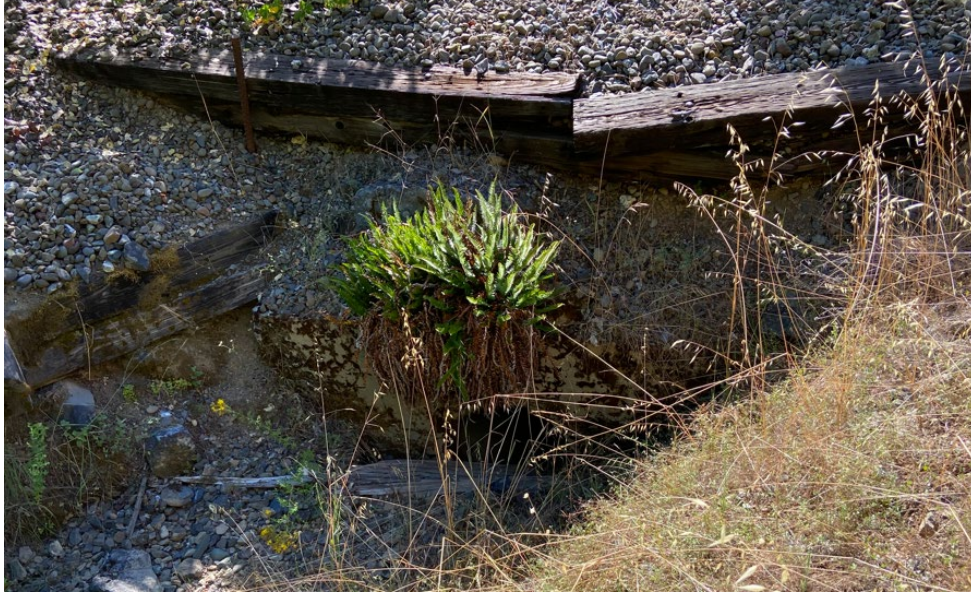
The lack of culvert maintenance over the last 24 years was evident in the field inspection. In general, culvert inlets need clearing of debris and sedimentation and repair of headwalls and wingwalls; and in many cases outlets require repair or installation of headwalls and wingwalls and have erosion that requires remediation, including riprap and possible tight lining down embankments. Based on the evidence of railroad track over-topping and review of drainage watersheds, some culverts are undersized, which is prevalent in railroads constructed in the early 1900's.

Photo 9 Example of ineffective headwall

- All culverts will need to be located and cleared of obstructions
- Small timber culverts require replacement
- 50% of the pipe culverts require headwall and wing wall repairs/replacements to address erosion
- The final program will require a detailed inspection of all culverts after removal of vegetation
- All culvert sizes need to be reviewed for capacity based on watershed hydraulics

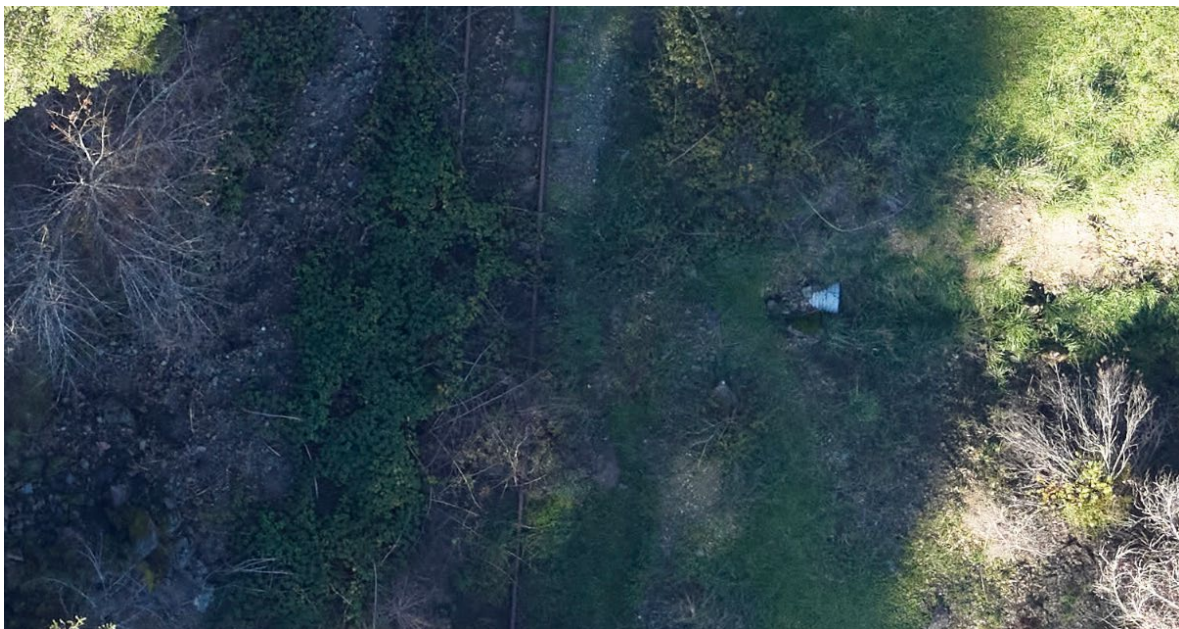
Photo 10 Case of culvert outlet erosion and possible culvert under sizing

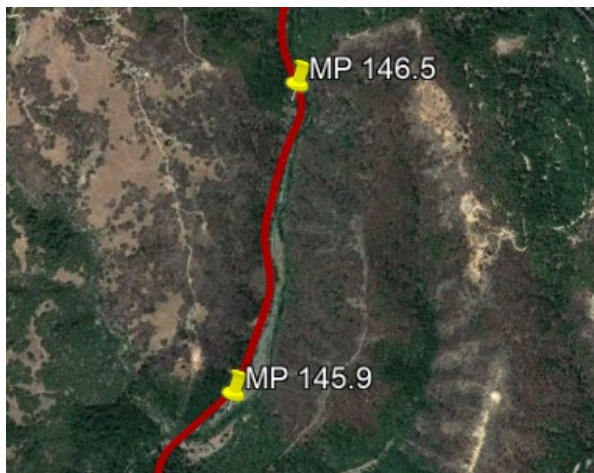
From MP 145.9 to 146.5 the track was subjected to a large forest fire. The fire destroyed all ties for this 0.6 miles of track. In this area the most economical rehabilitation is a complete replacement of the track ties and ballast. Field observations indicated that much of the ballast does not meet railroad ballast specifications. The rail was visually inspected, and it appears that the heat of the fire did not impact the rail and it can be relayed. The rebuild of this segment assumes removal of the rail to be set aside and relayed, replacement of 100% of the ballast (existing non-compliant ballast stockpiled for other use) and installation of all new ties. The rail would be relayed and the ties would be surfaced and regulated. See photos below of fire damaged area, tie damage and substandard ballast.

Photo 11 Area of fire damage

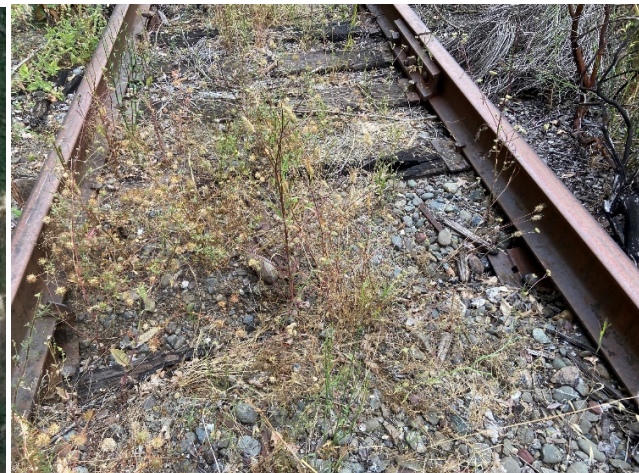
Photo 14 Fire damaged track and substandard ballast.

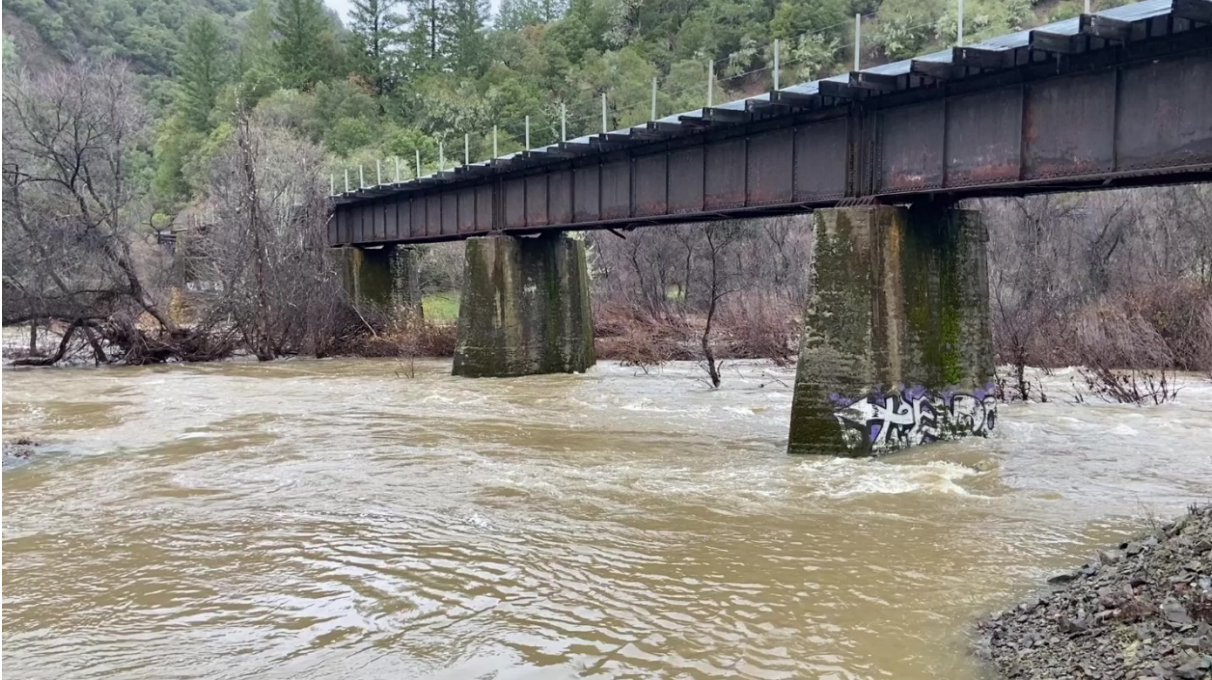
Photo 15 Bridge 151.99 Outlet Creek heavy flow

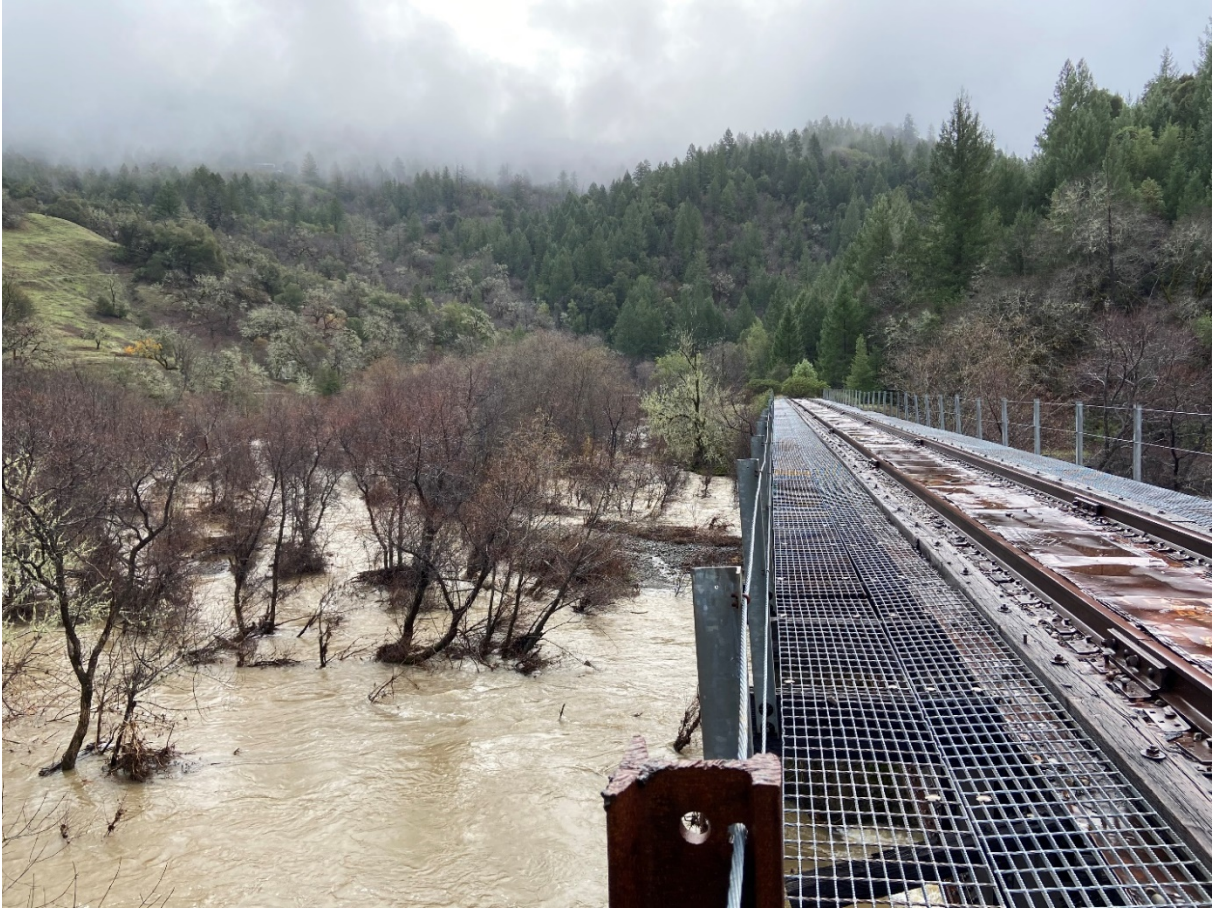
Photo 16 Bridge 151.99 Outlet Creek overflowing banks

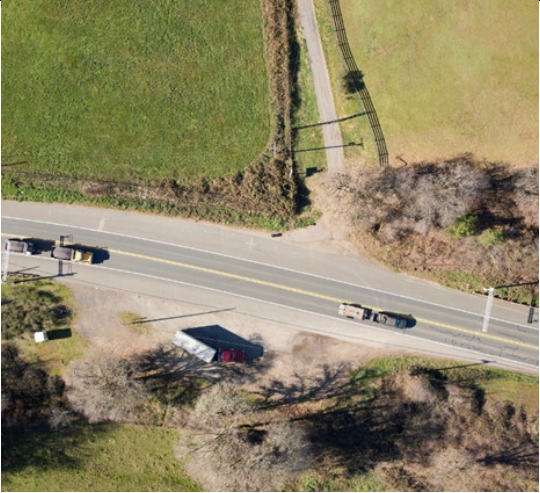
Crossings	Mile Post	Recommendation	Comments	Photo
Highway 101	MP 141.2	Install 200-foot curved track crossing with concrete panels, Install active constant warning devises including gates and cantilevers, approach roadway signs and address driveway entrance that lays within the crossing.	Tree removals along highway will be required to improve train crew line of site. Crossing skewed 60 degrees.

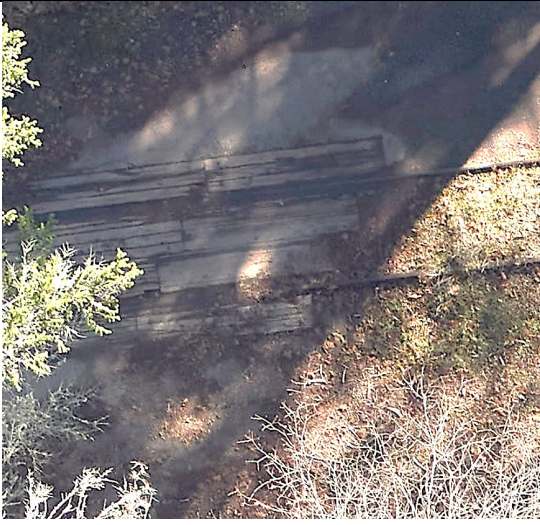
Reynolds Highway	MP 143.91	Reconstruct existing very poor 24-foot timber crossing with a concrete panel crossing, add appropriate approach warning signs.	Tree Trimming required S.W. & N.E. Quadrants. Crossing skewed 30 degrees.

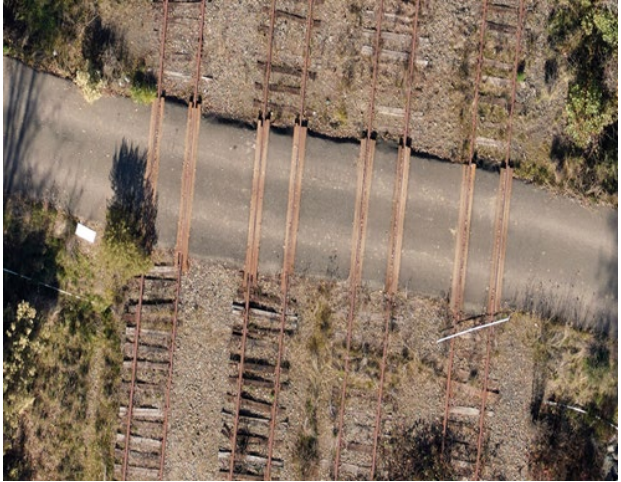
Crossings	Mile Post	Recommendation	Comments	Photo
Located in Willits Yard	MP 140.00	Crossing in good condition. Constructed as part of Highway 101 Bypass. Crossing signs required	Tree removal on west approach to railroad may require additional tree removal for line of sight.

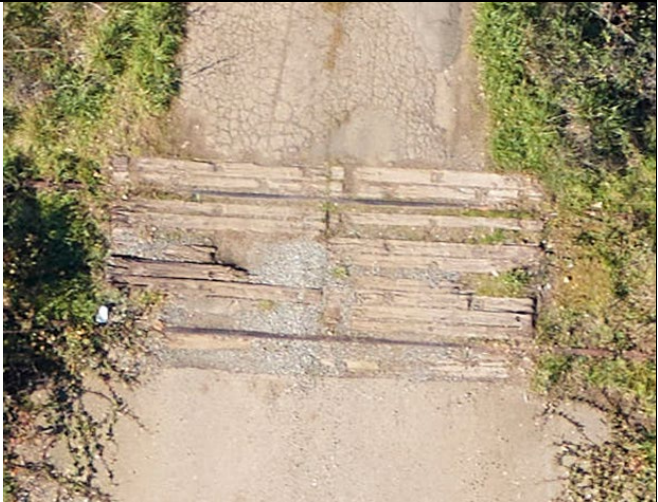
Private Resident	MP 141.40	Reconstruct existing very poor 24-foot timber crossing with a concrete panel crossing, add appropriate approach warning signs.	One residence

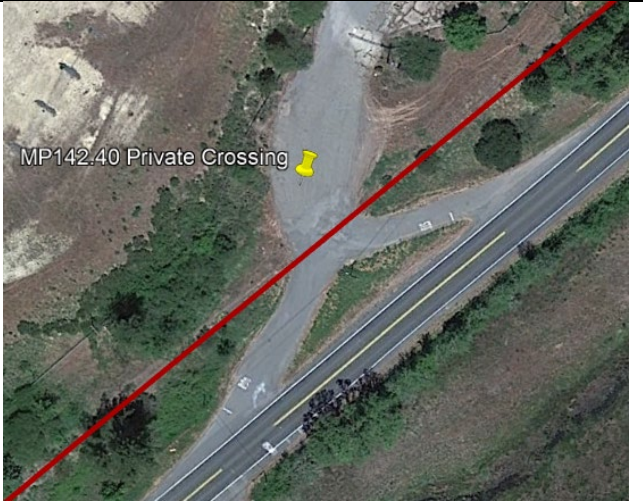
Crossings	Mile Post	Recommendation	Comments	Photo
Mendocino Forest Products Crossing	MP 142.03	Heavy truck usage, earthwork activities. Crossing parallel to 101 with wide angle egress and entrance roads to crossing from 101. Signing and reconstruction of paved over crossing required	This will be a costly repair.

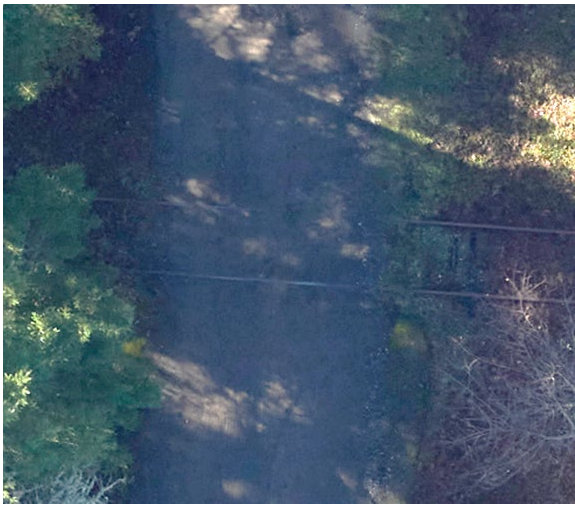
Serves Several private residences	MP 142.68	Poor condition Rail exposed

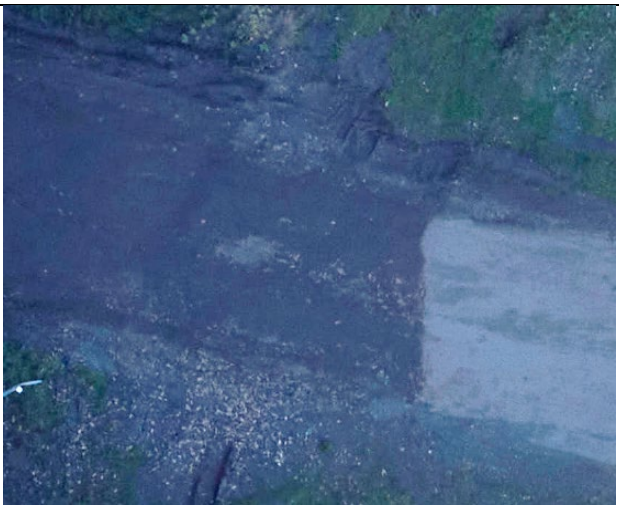
Private Residence may include addition homes	MP 142.77	Crossing in poor condition. Gravel track buried

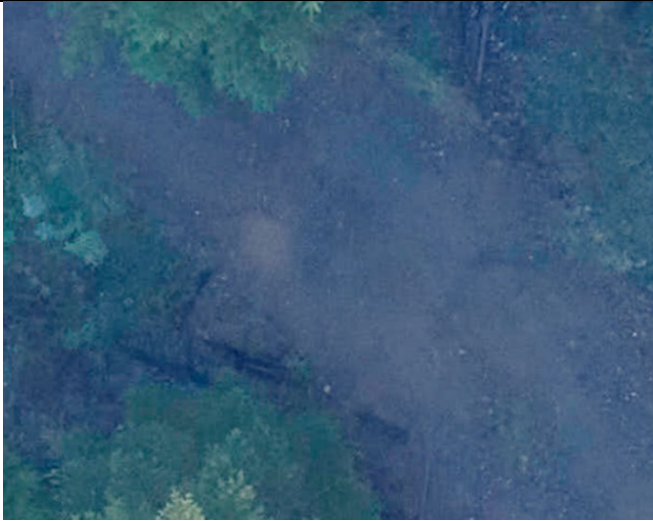
Crossings	Mile Post	Recommendation	Comments	Photo
One Resident	MP 145.60	Crossing in poor condition. Gravel track buried	Timber crossing planks in very poor condition

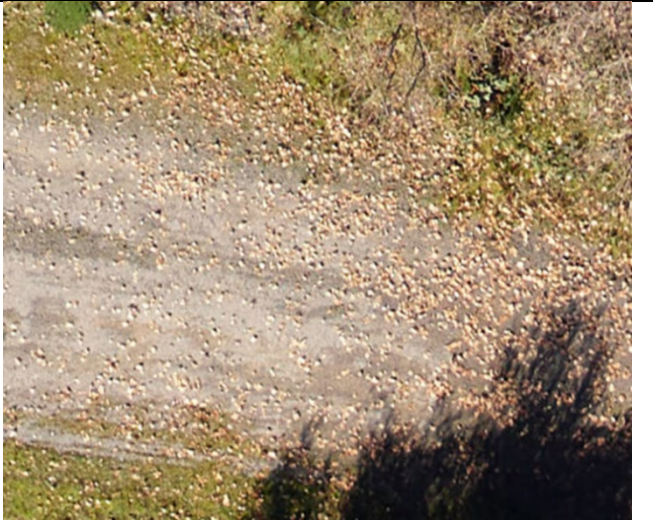
Serving one parcel	MP 148.34	Crossing in poor condition. Gravel track buried.

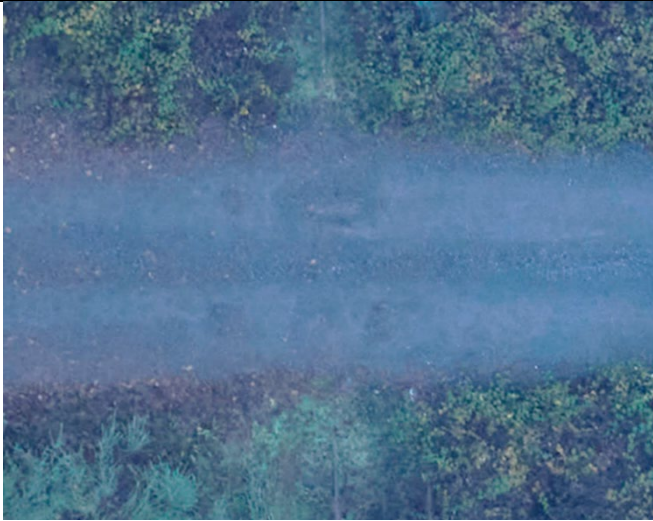
Serving one residence	MP 148.41	Crossing in poor condition. Gravel track buried

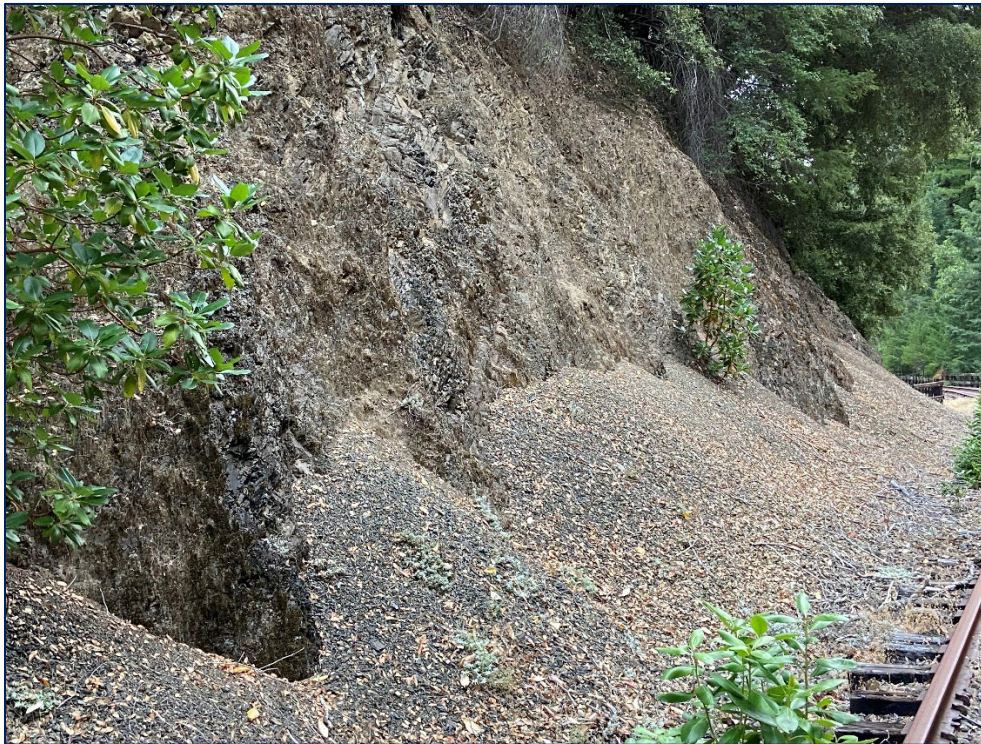
Exhibit 4-3 – Photo 65 – Fragments of highly fractured siltstone and mudstone raveling from rock slope at approx. MP 147.3

The weak sheared zones consist of fissile mudstones that easily disaggregate, commonly forming talus deposits at the slope base (see Exhibits 4-3 and 4-4). These shear zones typically create soft topography of gently sloping and rounded, lumpy, and irregular, poorly-incised topography, or irregular topography lacking well-incised sidehill drainages (see Exhibits 4-7 and 4-8).

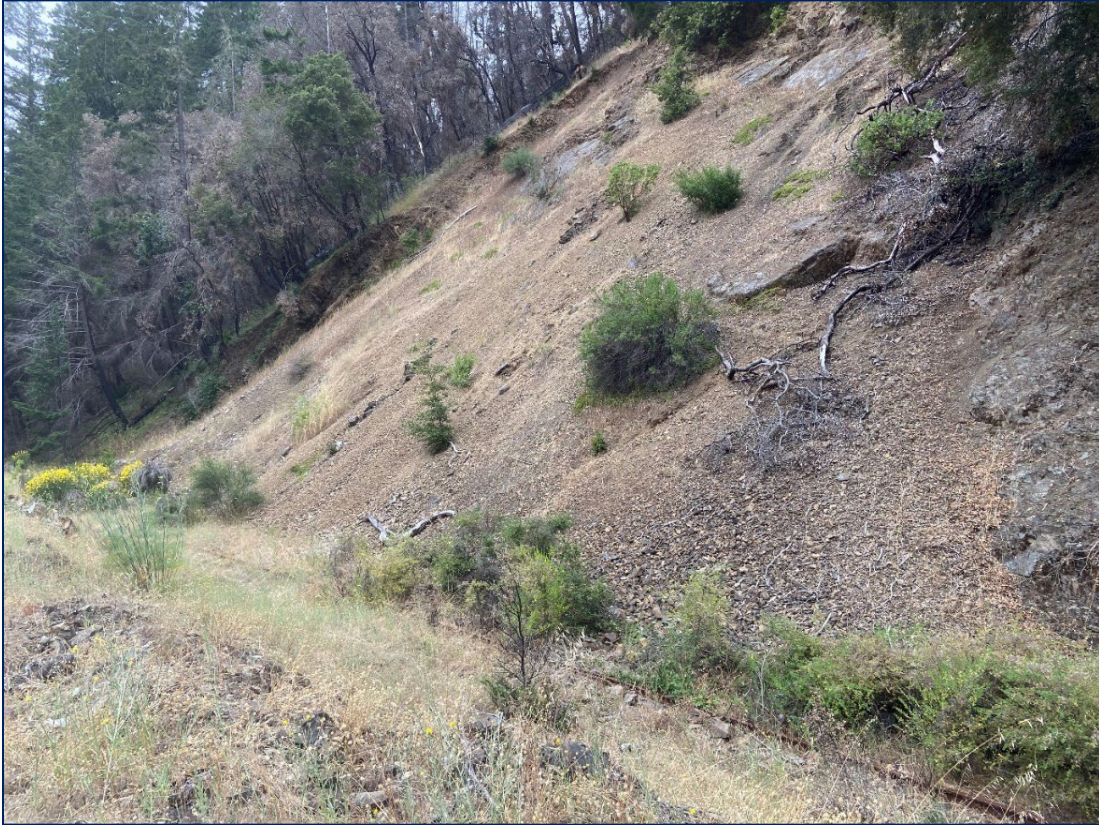
Exhibit 4-4 - Photo 95 – Highly fractured siltstone and mudstone interbedded with blocky sandstone exposed on slope at approx. MP 146

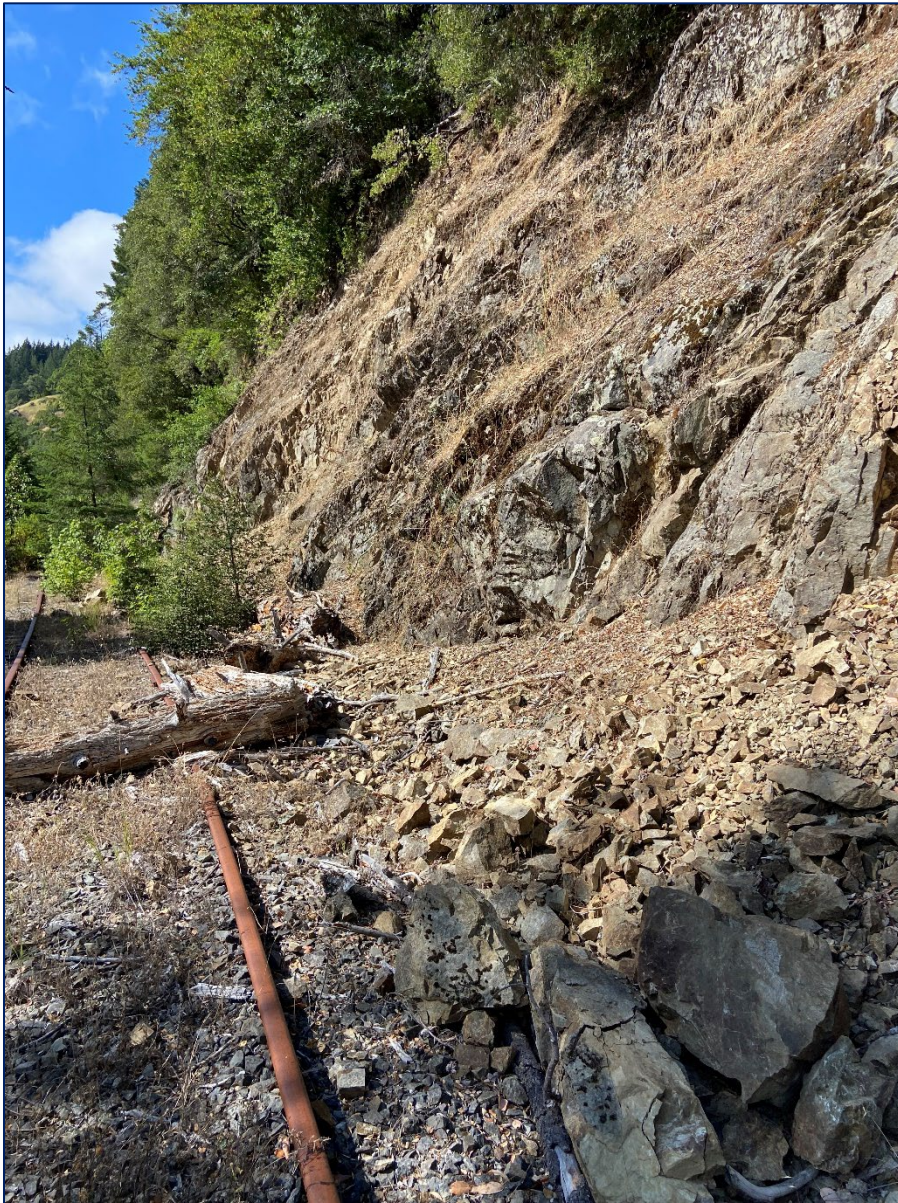
Exhibit 4-5 - Photo 15 – Folded and fractured sandstone and siltstone rock slope at approx. MP 151.87

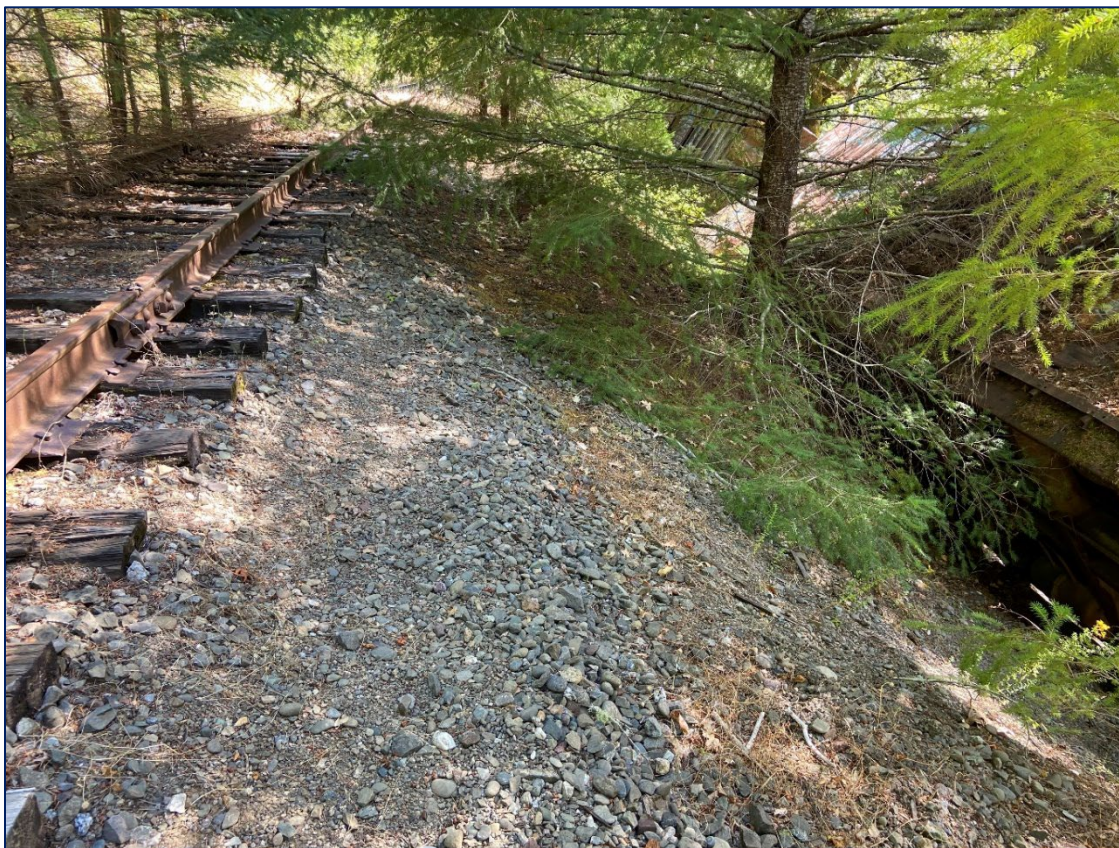
As a result of the location of the railroad, landsliding on steep slopes along the railroad deposit landslide debris onto the railroad (see Exhibits 4-3 and 4-4) and stream flow in Outlet Creek erodes the railroad embankment (see Exhibits 4-6 and 4-9).

Exhibit 4-9 - Photo 17 – Narrow shoulder and derailed cars at MP 151.9
