**SPECIAL MEETING AGENDA**

## Interim Corrective Action and Storm Water Rerouting Project Fort Bragg Mill Site – July 2010

Mill Pond Dam, No. 2381  
Mendocino County

**INSPECTION OF DAM AND RESERVOIR IN CERTIFIED STATUS**

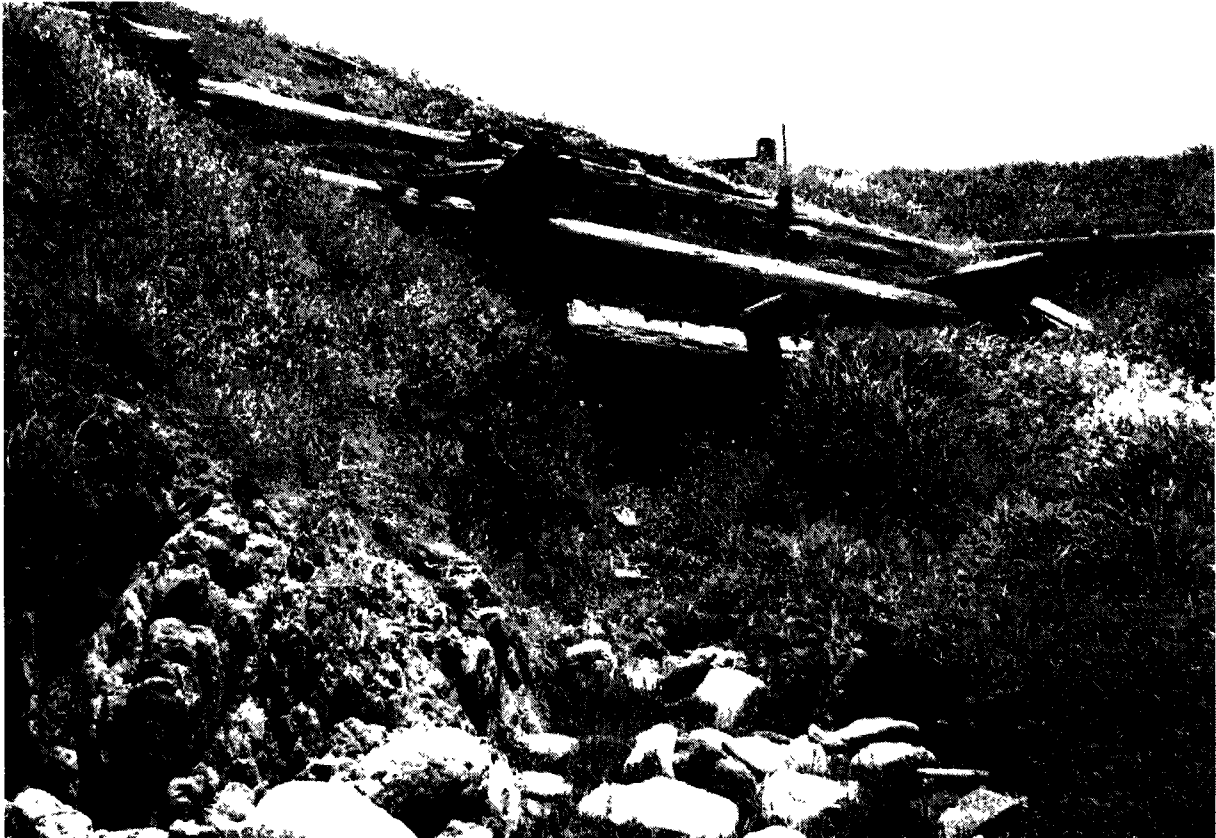
**Embankment:** In the absence of any substantive maintenance, the timber-cribbing wall to the left of the spillway remains in very poor condition and continues to deteriorate. Embankment material continues to be transported from behind the wall, opening voids and causing a loss of contact and support between the structural timbers and the supported embankment.

The timber-cribbing wall to the left of the spillway remains in very poor condition and continues to deteriorate. Embankment material continues to be transported from behind the wall, opening voids and causing a loss of contact and support between the structural timbers and the supported embankment.

1. Fill the large void at the timber supported portion of the embankment with compacted fill, and protect the restored surface with rock or other suitable material.

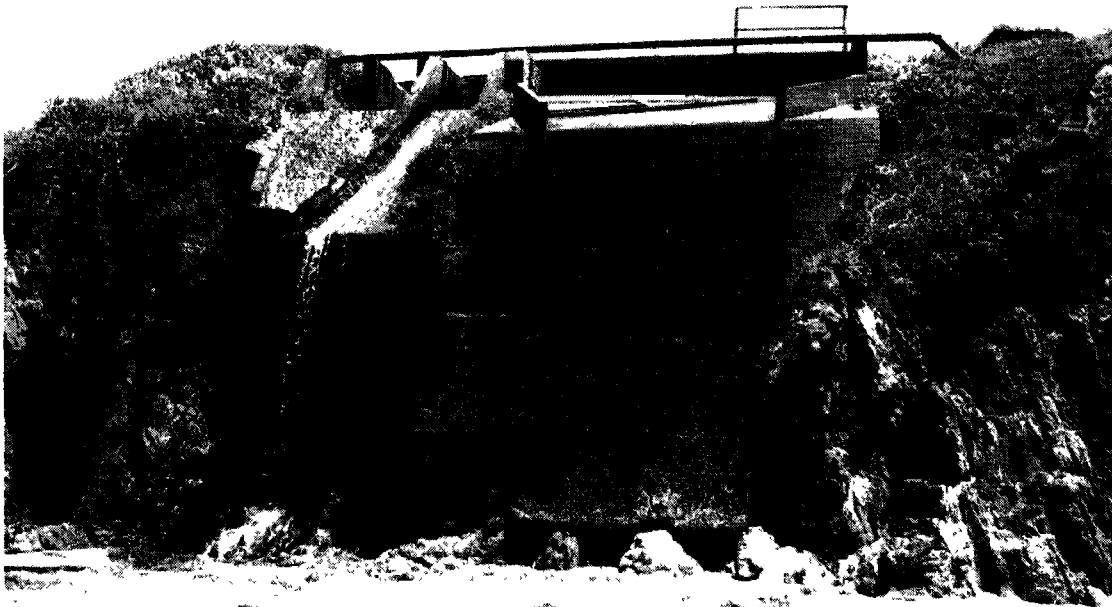
The concrete spillway (top photograph, above) is also deteriorating, and rebar is exposed beneath and behind the concrete facing (bottom photograph, below).

2. Patch the damaged base of the reinforced concrete spillway structure.
3. Remove the tule growth along the downstream toe of the right embankment. If live flow is detected afterwards, evaluate the source and significance of this seepage.
4. Clear the brush and dense vegetation that obstructs the embankment, groins, and abutments.
5. Clear the vegetation that obstructs the spillway entrance.

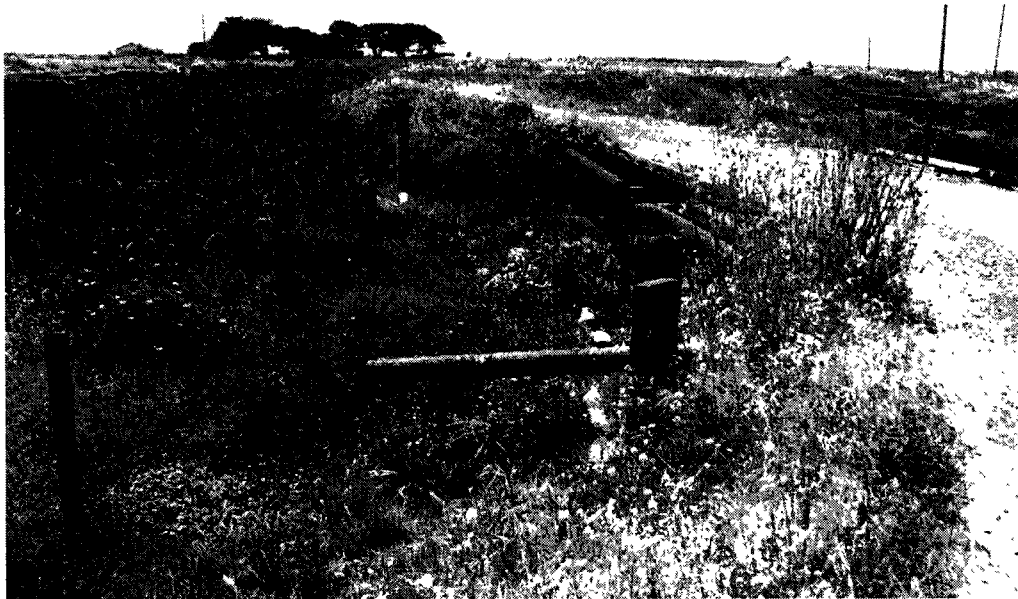
**Spillway:** The spillway entrance is partially impeded by dense vegetation. Abundant floating vegetation throughout the pond, including immediately adjacent to the spillway entrance, makes the possibility of clogging of the spillway with floating vegetation and other debris during a storm a concern. The control section and exit channel were open and clear, and all flashboards have been removed from the spillway section. The "Petro Barrier" was in place in front of the spillway entrance.

The spillway entrance is partially impeded by dense vegetation (top photograph, above). Abundant floating vegetation throughout the pond, including immediately adjacent to the spillway entrance, makes the possibility of clogging of the spillway with floating vegetation and other debris during a storm a concern.

The spillway entrance is partially impeded by dense vegetation. Dense vegetation must be removed from in front of the spillway entrance and measures taken to prevent clogging of the spillway by vegetation during storm flows.

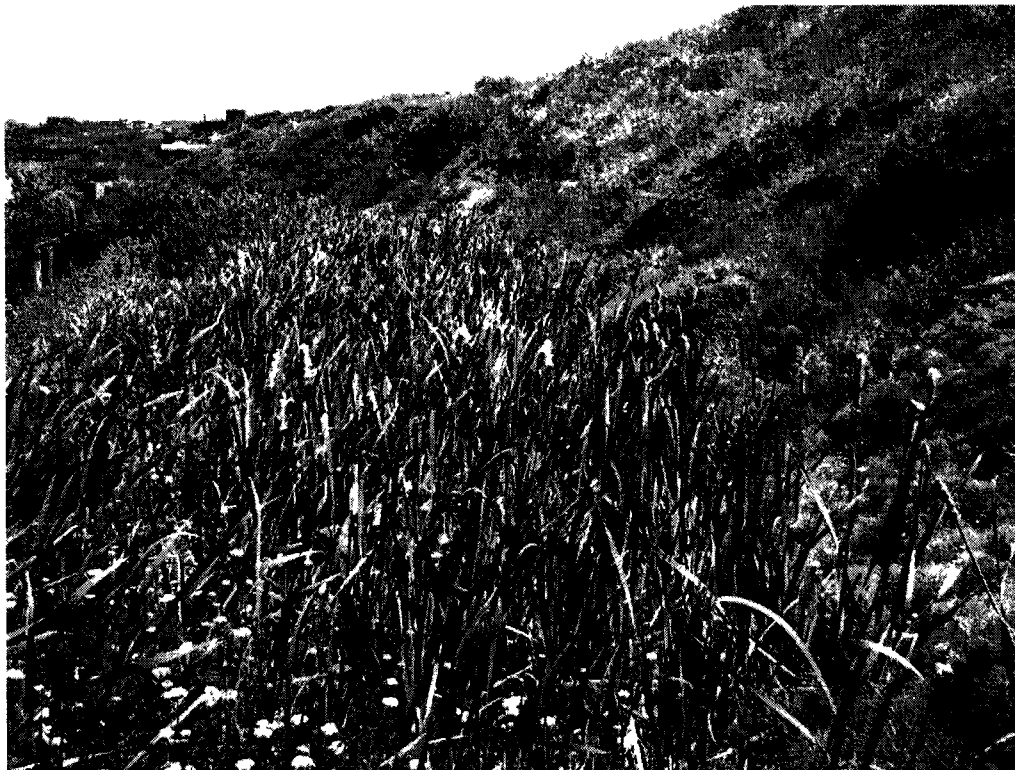
Standing water occupies the downstream toe of the right embankment at the former location of a water treatment plant. While several supply and feed pipes from the facility are known to perforate the embankment in this area, neither the condition of the pipes nor the status of pipe encasements is known. It appears likely that seepage from, or around, the pipes are a likely source of the seepage observed. While the seepage appears to be clear, tall and dense vegetation within the standing water prevents a thorough evaluation of seepage conditions.

Standing water occupies the downstream toe of the right embankment at the former location of a water treatment plant (bottom photograph, above). While several supply and feed pipes from the facility are known to perforate the embankment in this area, neither the condition of the pipe nor the status of pipe encasements is known. It appears likely that seepage from, or around, the pipes are a likely source of the seepage observed.

Standing water has accumulated within low areas along the right embankment toe. Supply pipes to and from the pond perforate the embankment within this area, and neither the condition of the pipes nor the status of encasement of the pipes is known. I directed Mr. Heitmeyer to investigate the cause of the seepage and to make whatever repairs are necessary to prevent uncontrolled seepage from damaging the embankment.
