Attachment F

Railroad Rehabilitation Assessment
Willits MP 139.5 to Longvale MP 152.5

This Assessment was completed to determine an estimated cost necessary to rehabilitate 13 miles of GRTA Rail Line from Willits, CA MP 139.5 north to Longvale, CA MP 152.5 to FRA Class 1 track standards for freight rail service.

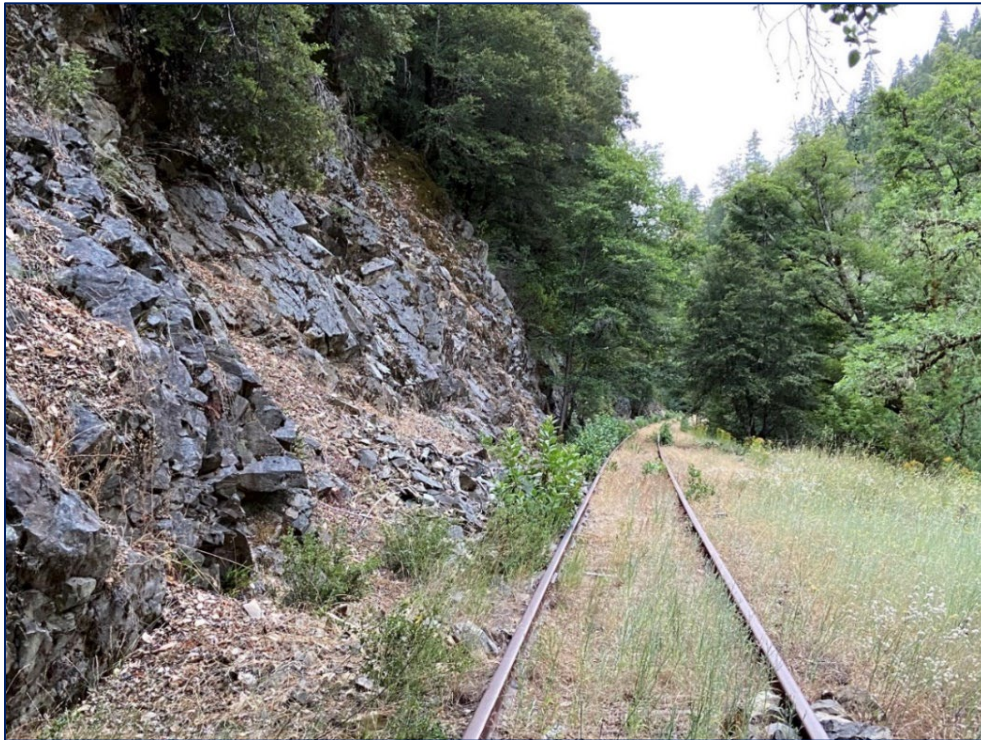
The Coastal Terrane unit (TKfs) or “broken formation” is Late Cretaceous to Early Eocene age and consists mainly of thickly bedded sandstone (see Exhibit 4-2), with siltstone and shale interbeds with zones of brittle shears, folding, and faulting (see Exhibits 4-3, 4-4 and 4-5). It also contains sections of deep-water marine argillite, and lesser amounts of limestone and pillow basalts.

Exhibit 4-2 – Photo 60 – Blocky sandstone rock slope at approx. MP 147.5

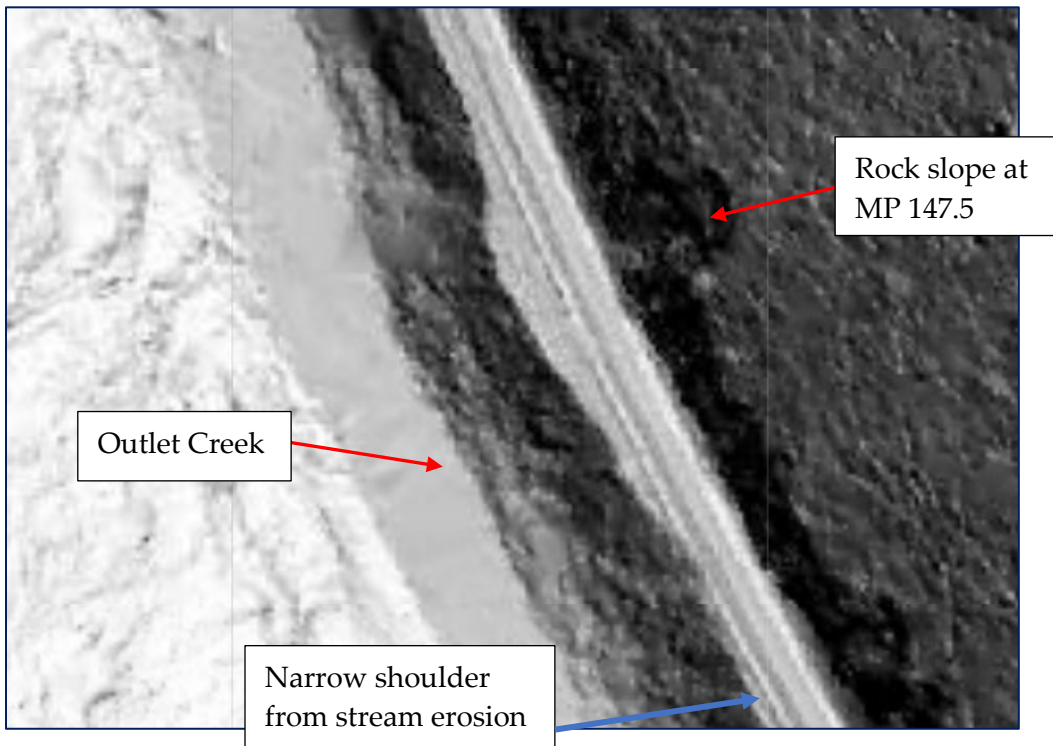
The intact blocks tend to form hard ridges of steep, sharp-crested topography (see Exhibits 4-6 and 4-7) with a well-incised system of irregular sidehill drainage.

Exhibit 4-6 – LIDAR image of rock slope at about MP 147.5 (see Exhibit 2)

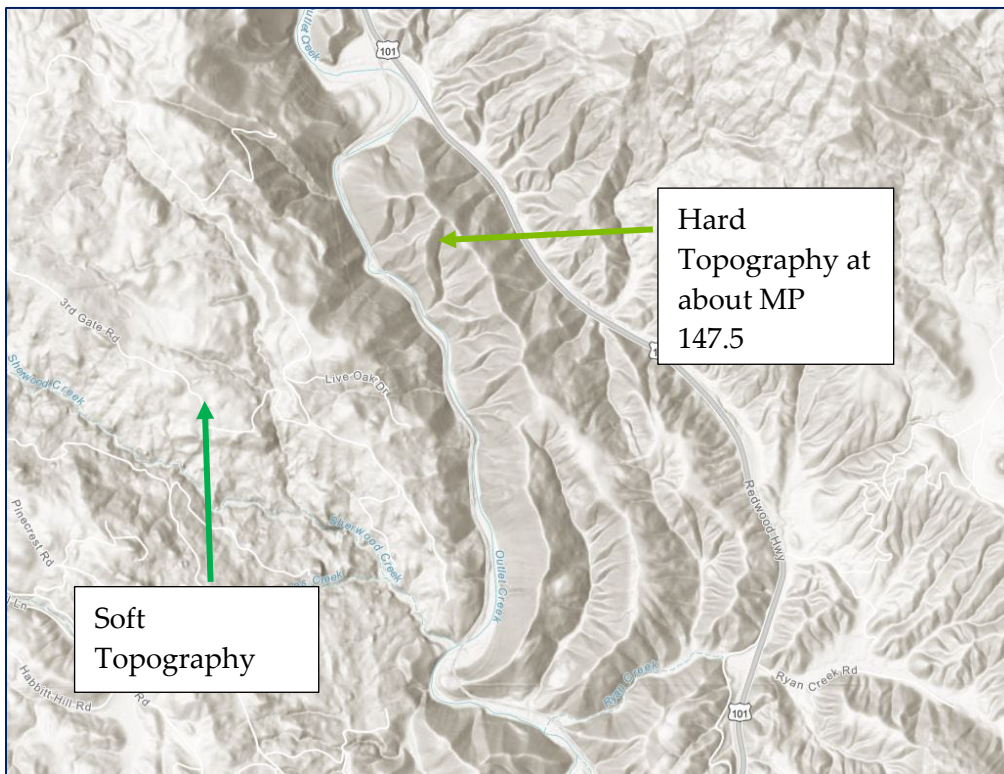
Exhibit 4-7 – LIDAR image snip from USGS National Map – Showing “Hard and soft topography” areas

The weak sheared zones consist of fissile mudstones that easily disaggregate, commonly forming talus deposits at the slope base (see Exhibits 4-3 and 4-4). These shear zones typically create soft topography of gently sloping and rounded, lumpy, and irregular, poorly-incised topography, or irregular topography lacking well-incised sidehill drainages (see Exhibits 4-7 and 4-8).

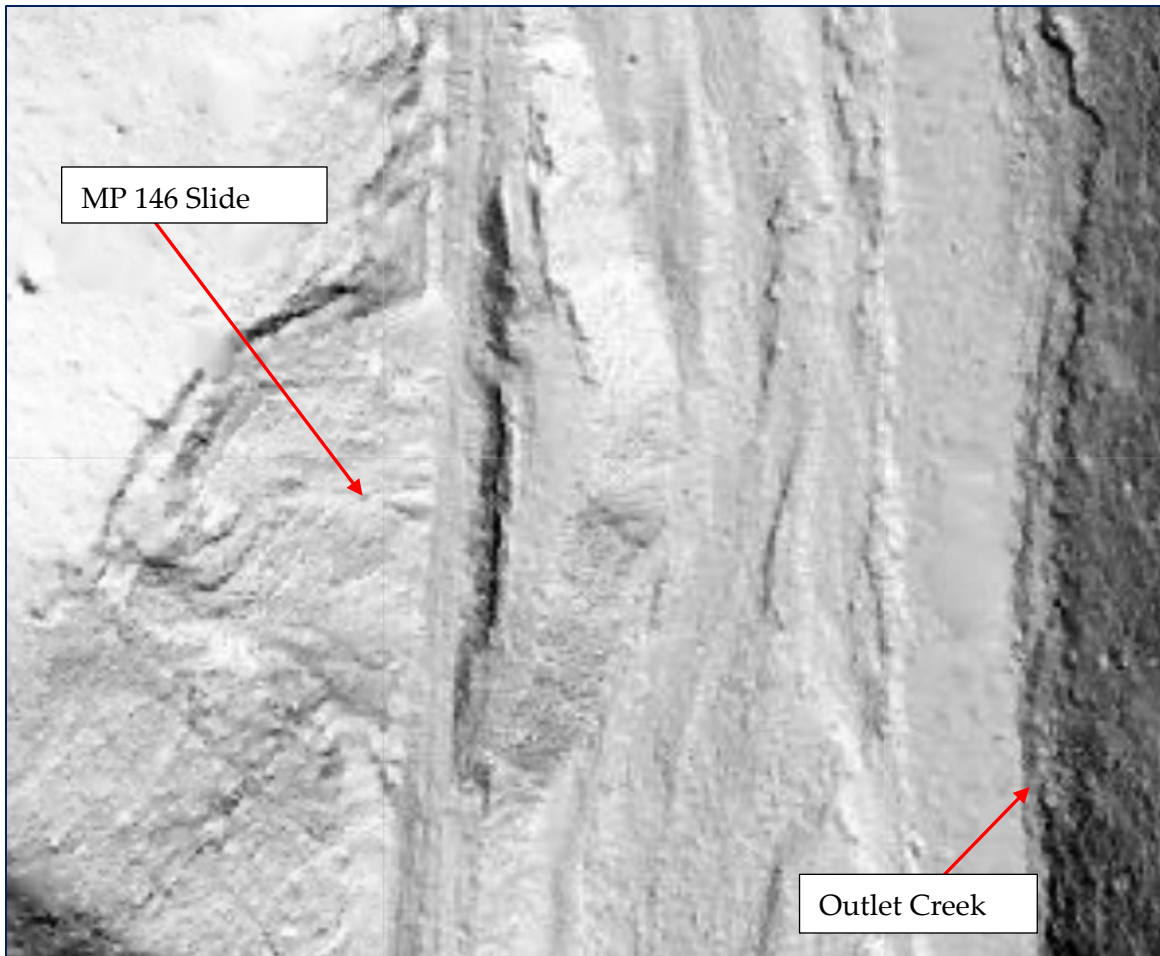
Exhibit 4-8 – LIDAR image of rock slope and landslide at about MP 146 (see Exhibit 4-4)
